**Results of the Field
Reconnaissance Survey of
the Ringwood
Mines/Landfill Site,
Ringwood, New Jersey**

Prepared for:
Ford Motor Company

Prepared by:
ARCADIS G&M, Inc.
1200 MacArthur Boulevard
Mahwah
New Jersey 07430
Tel 201 236 2233
Fax 201 236 5110

Date:
3 October 2005

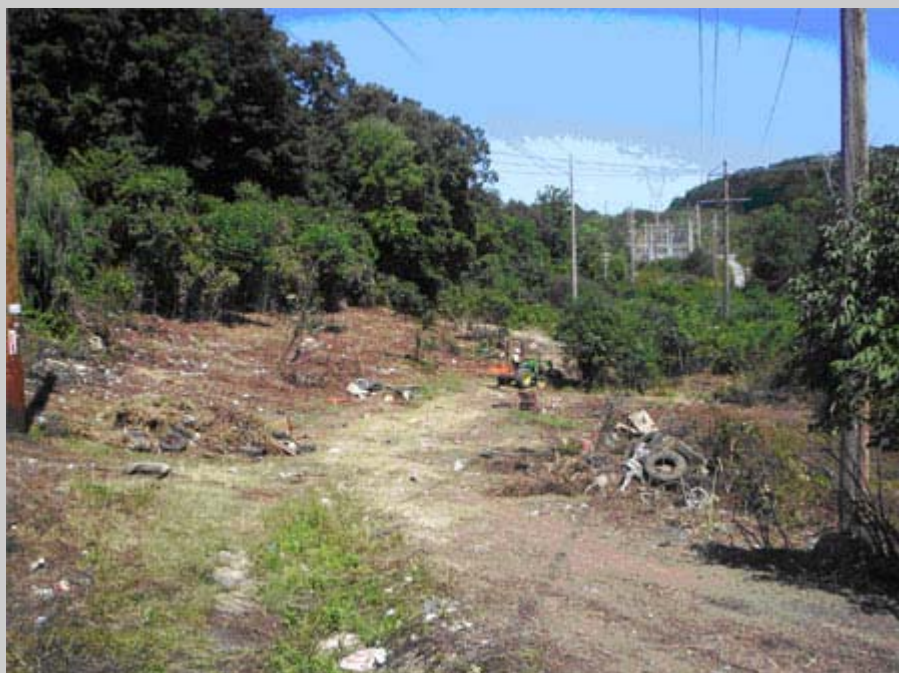
PHOTO 1. Existing refuse visible after brush clearing operations in Area 10B.

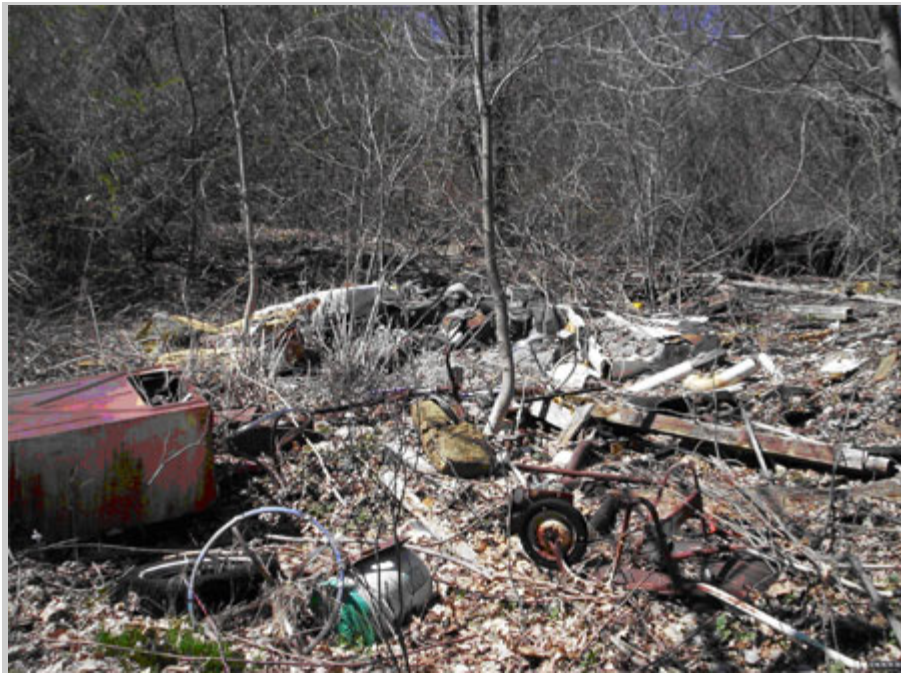
PHOTO 2. Large pile of household refuse located within Area 6

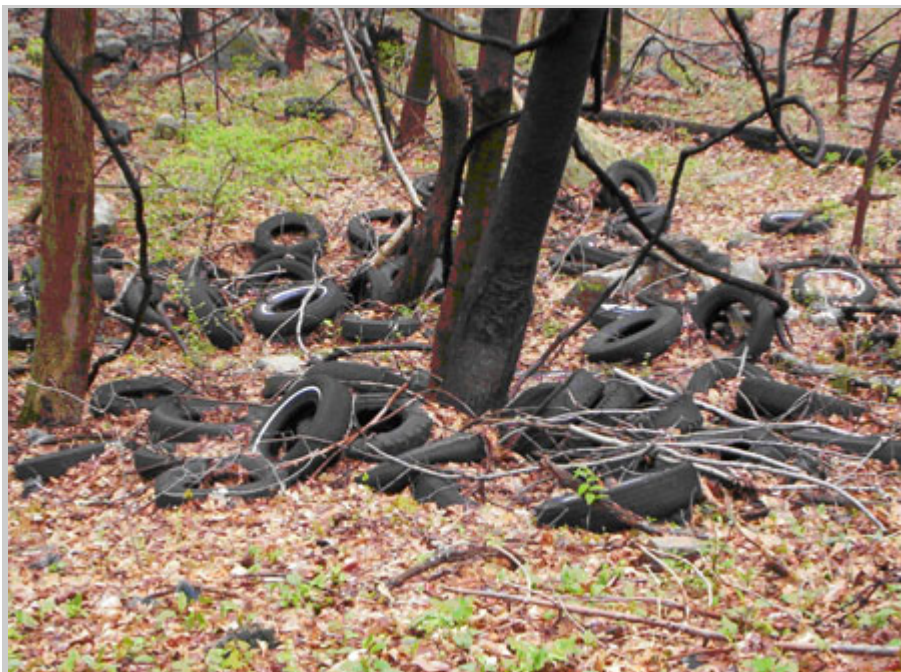
PHOTO 3. Pile of tires located downhill of Area 4.

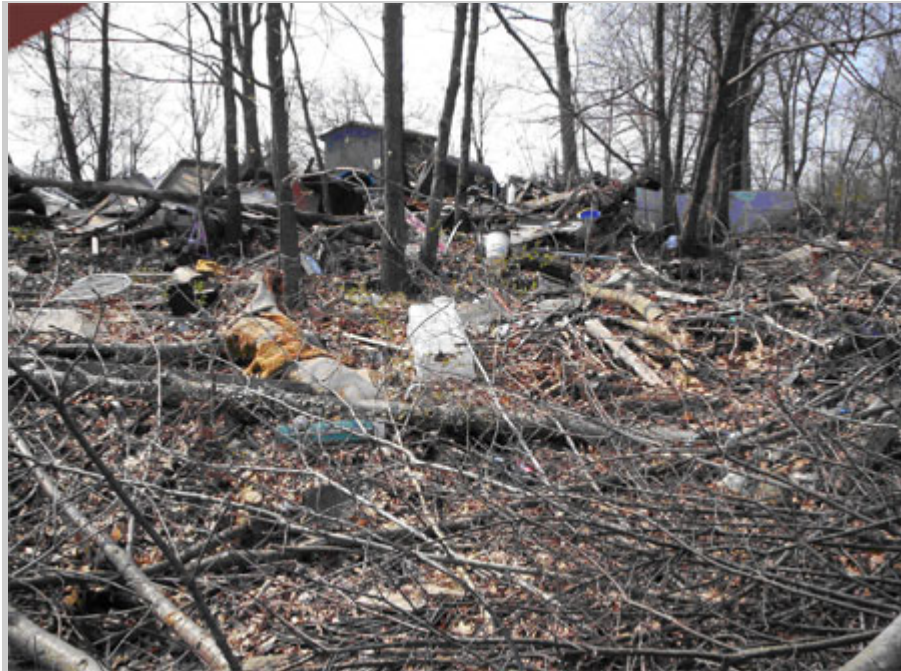
PHOTO 4. Pile of household refuse adjacent to a residential property within Area 10.

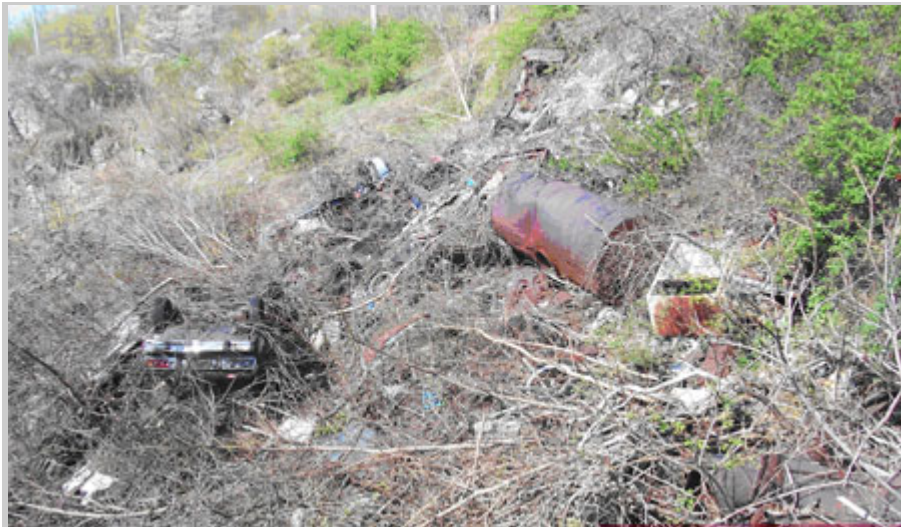
PHOTO 5. Refuse (cars, tires, AST/UST, etc.) downhill of Hope Mountain Road between Areas 2 and 4.

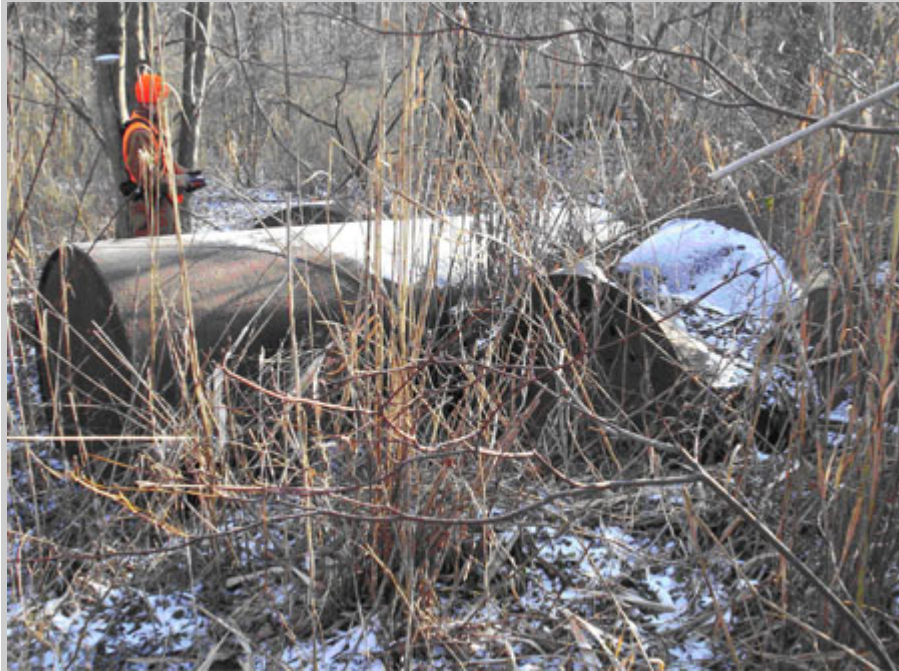
PHOTO 6. Two USTs/ASTs located during the field survey of Area 6.
